Rapid lube oil degradation after recent oil change – Problem solved for a major offshore Oil & Gas operator, in Qatar, by using DECON Solvancer® and Vita ESP III technologies.

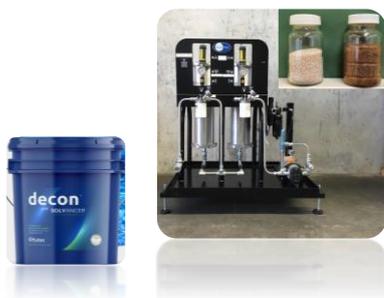
ESP (Electrophysical Separation Process) filtration unit combined with DECON flushing treatment.

DECON Solvancer® was added to the lube oil reservoir to dissolve the existent Varnish, control the deposits and prevent future varnish formation. In addition, the Vita ESP III unit was hooked up to the reservoir to remove the existent soluble and insoluble oil degradation products.
