Isolate Extensive Leaks and Reinstate Gas Lift Functionality with Retrofitted Multi-Run Straddle System

Date: Jan 2023
Region: Qatar

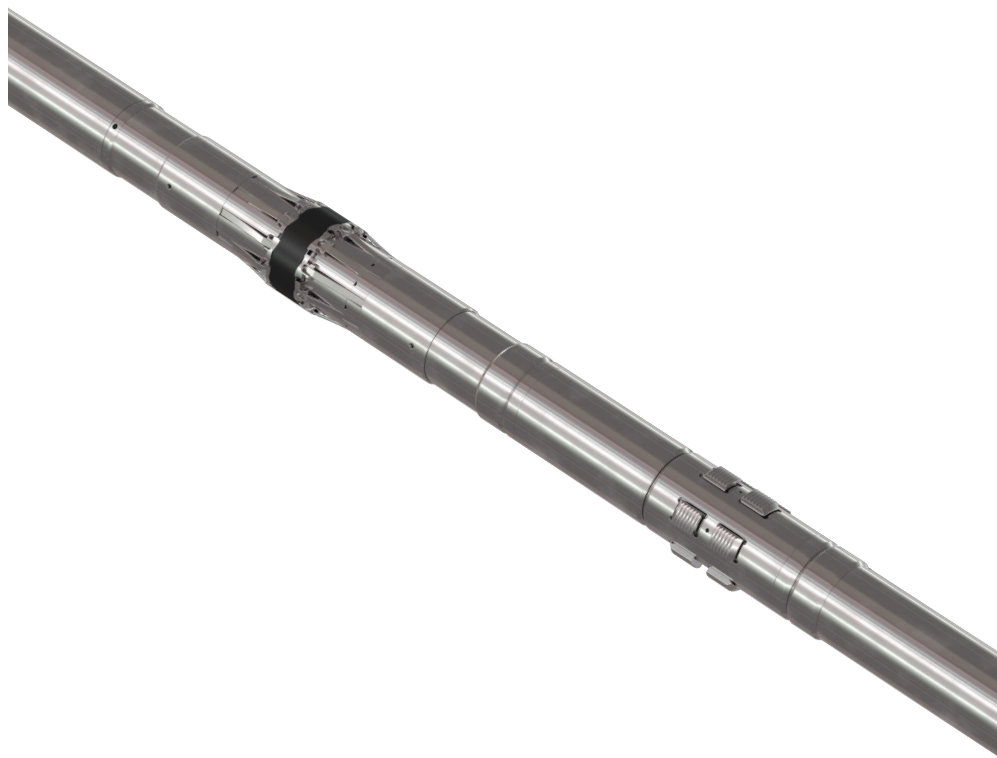
Multi-Run Anchored Production Straddle (APS).

Interwell proposed a multi-run anchored production straddle (APS) based on the ME design retrofitted with a PTC Go-lift sub to restore the gas lift capability. The APS was then customised to cover the entire leaking section including the SPM. The lower section was initially set followed by 2 sets of spacers on a GS, and finally, the upper section fitted with the PTC Go-Lift was latched onto the bottom sections.
